Residential Building Survey

1.2 Brief Summary and Recommendations

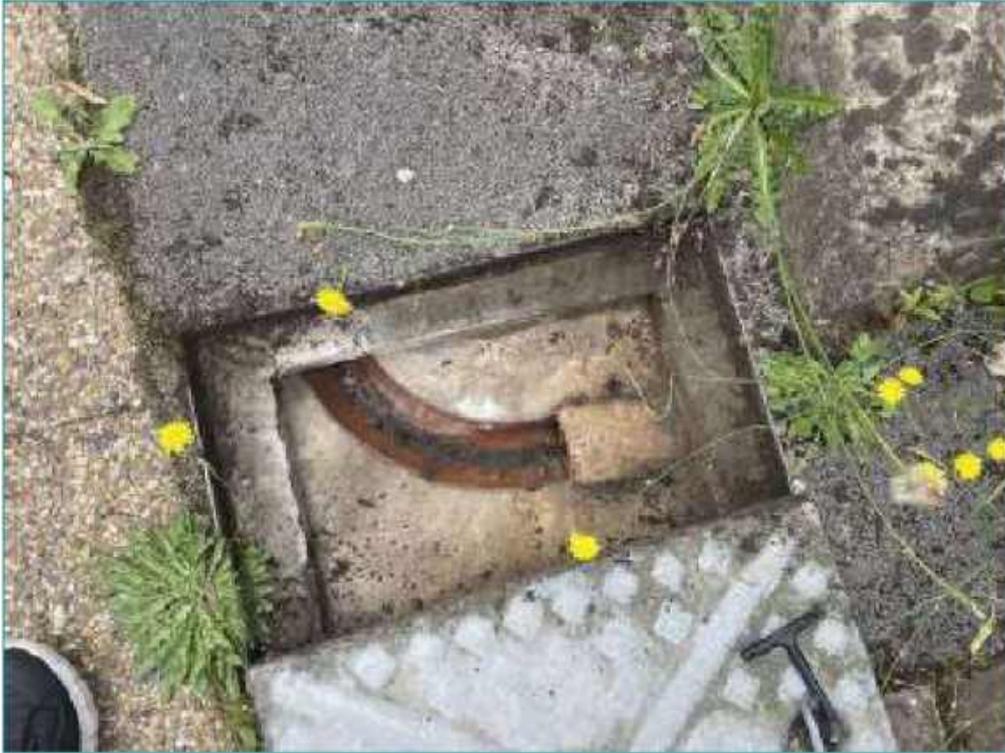
Manhole - lifted

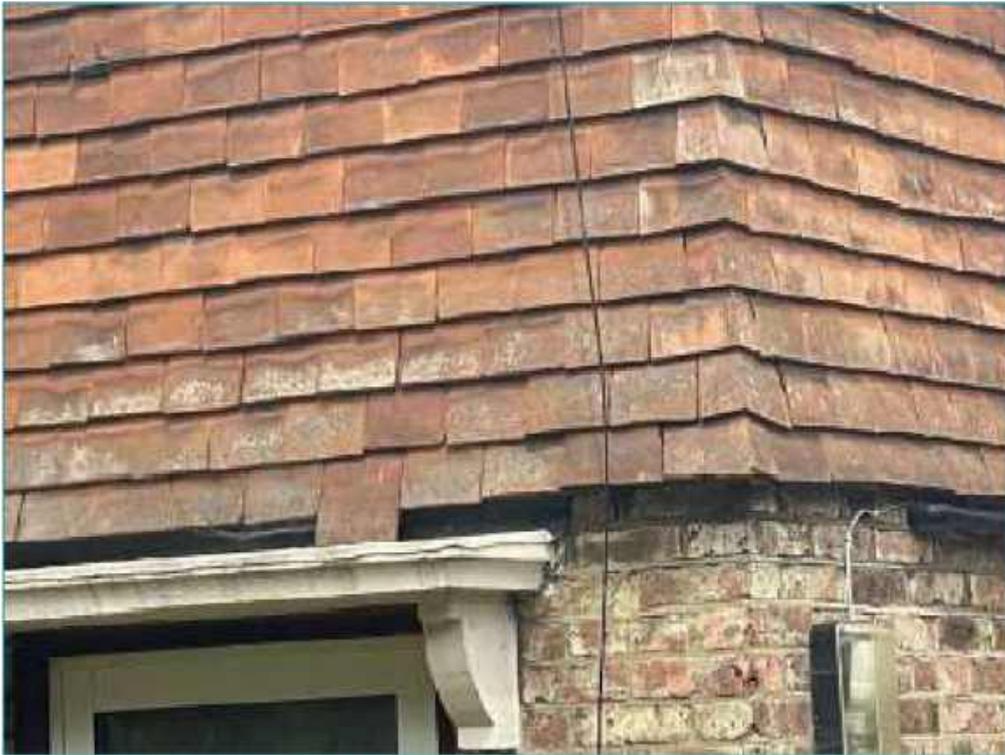
Front elevation - loose tiles

Some external (maintenance) works will be required, including snagging (which this report does not cover). Where hairline cracking, flaking/faded paintwork, open joints and areas of receded mortar may be present, we recommend a set of external redecoration works to include repointing, repainting and resealing in order to limit any potential lateral damp penetration occurring.

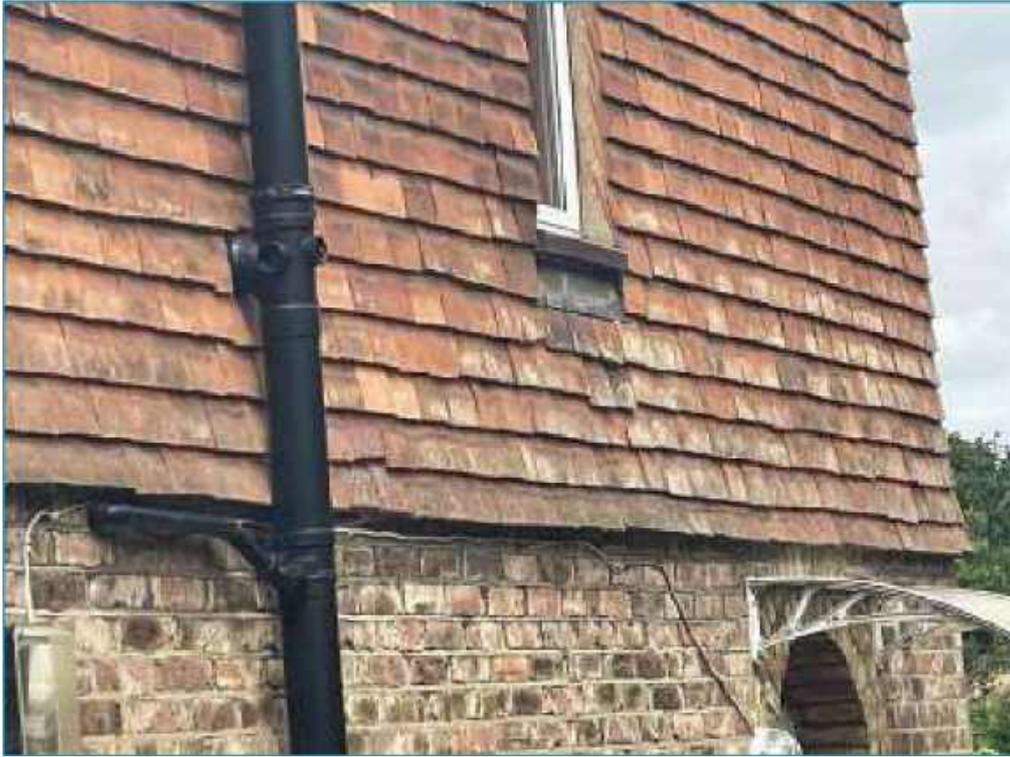
Side elevation - loose tiles

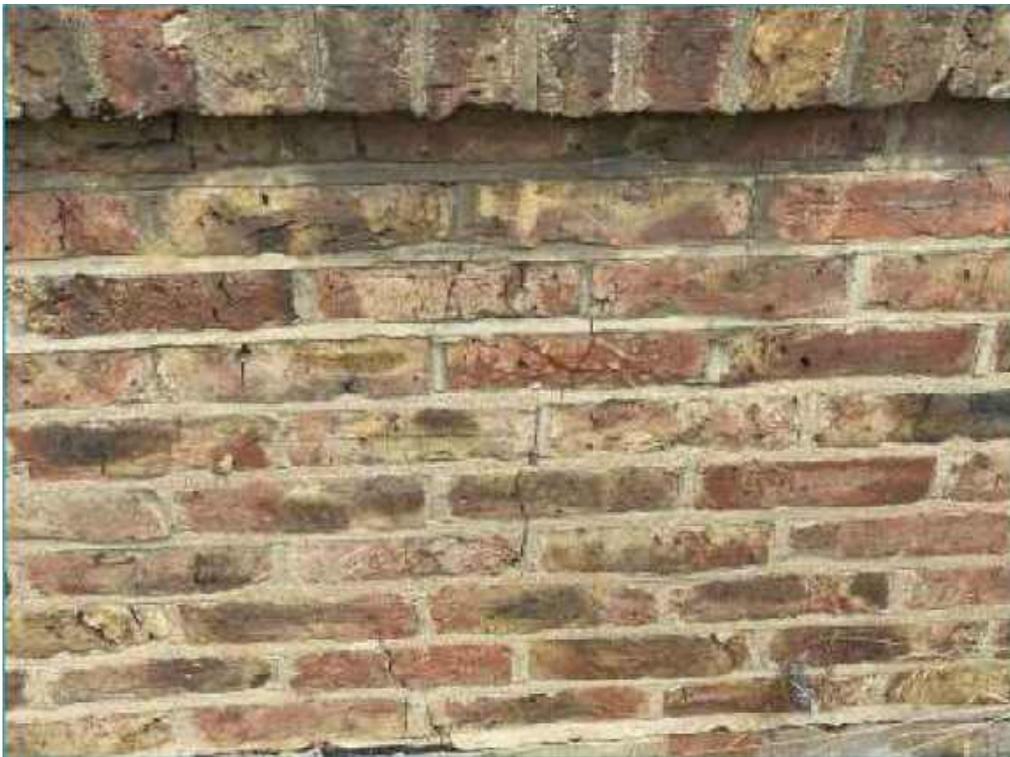
Front elevation - crack to the wall

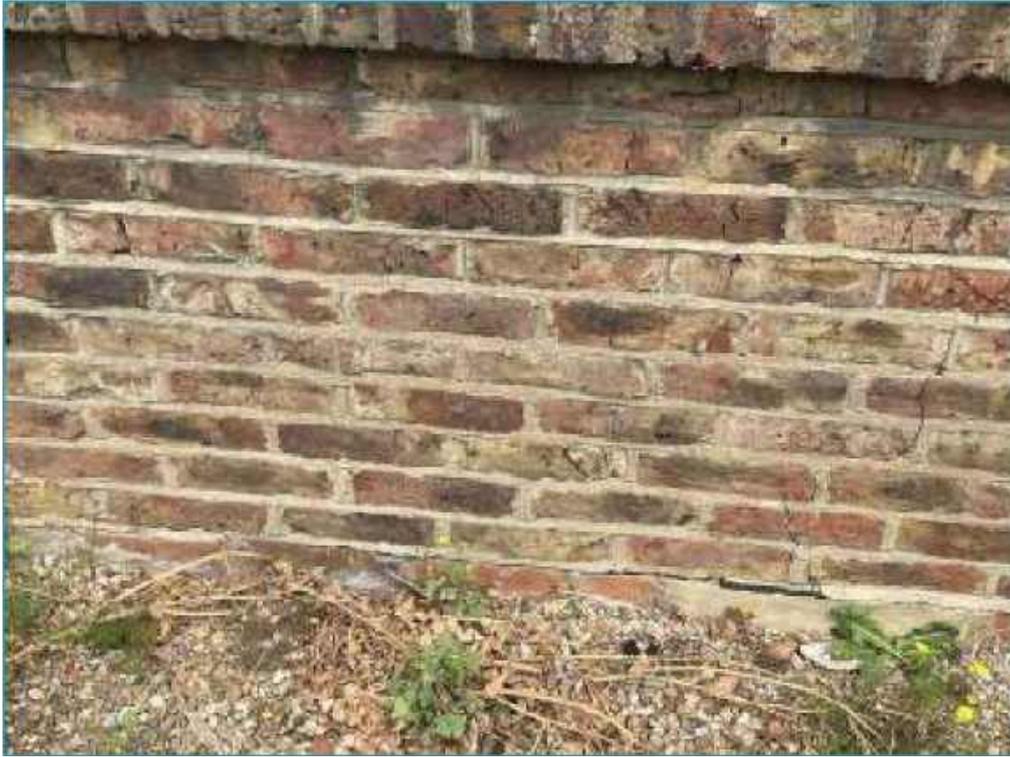
Side elevation - crack to the wall and receding mortar

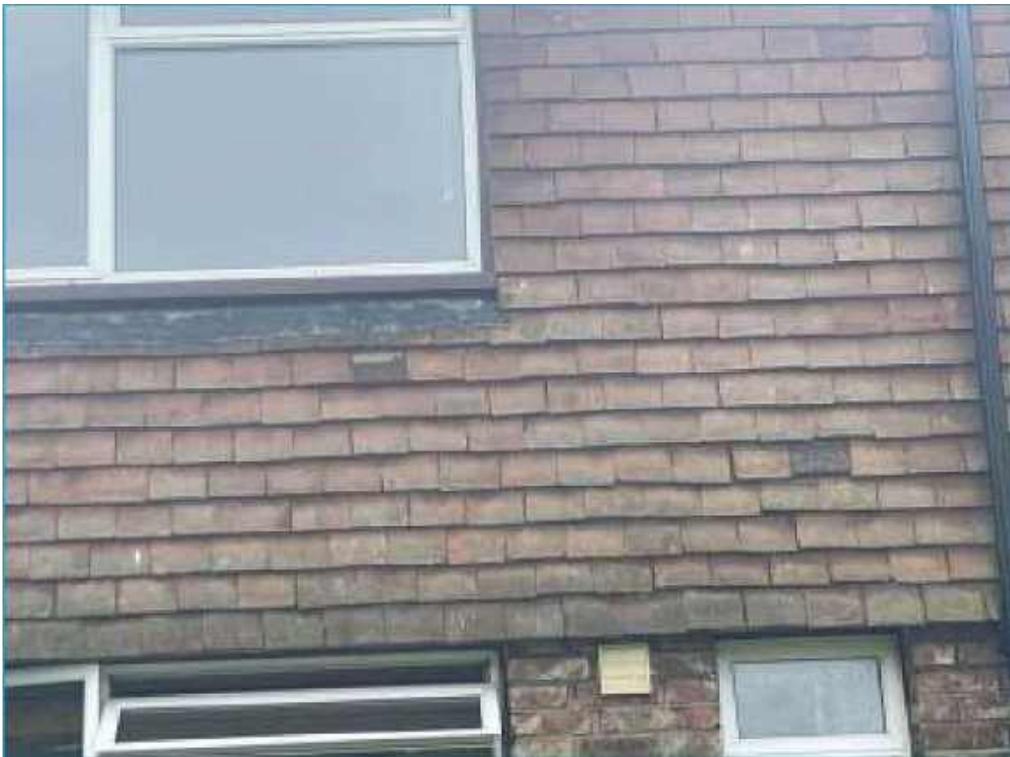
Rear elevation - loose tiles

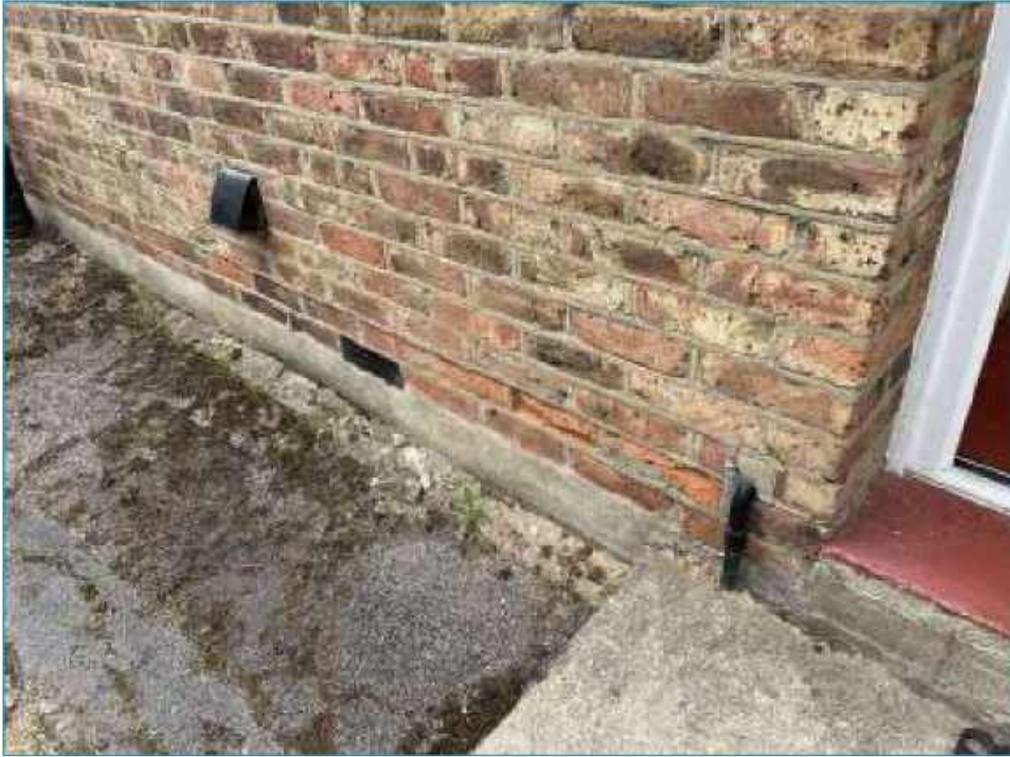
Side elevation - spalled brickwork and receding mortar

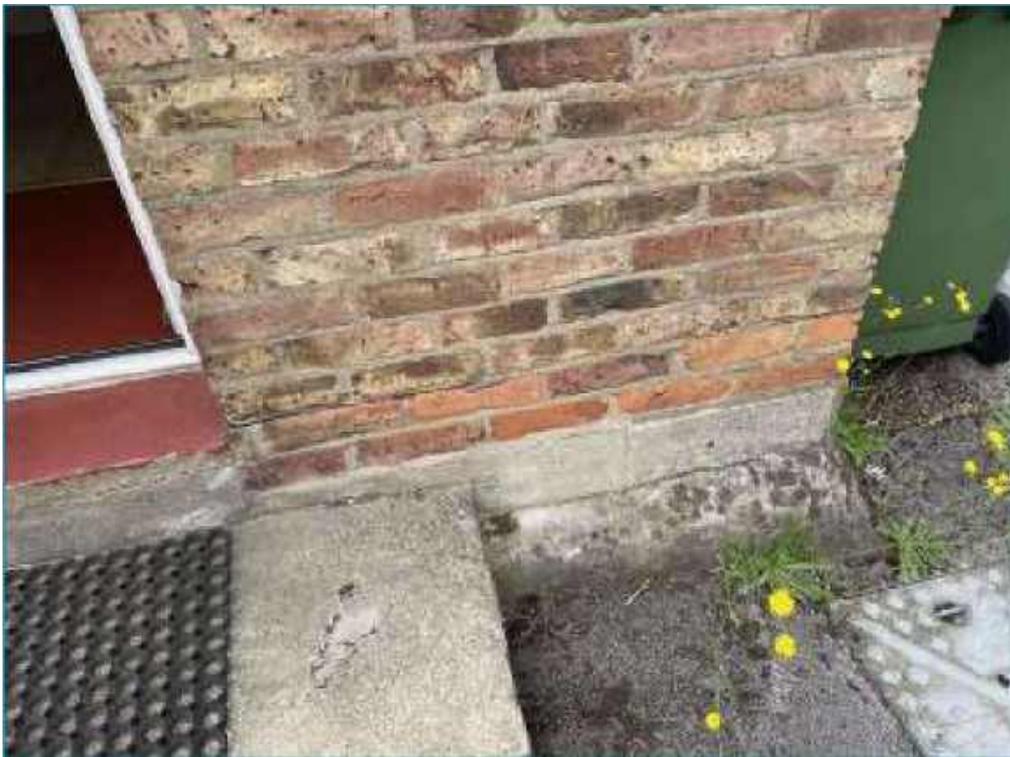
Side elevation - receding mortar and spalled brickwork

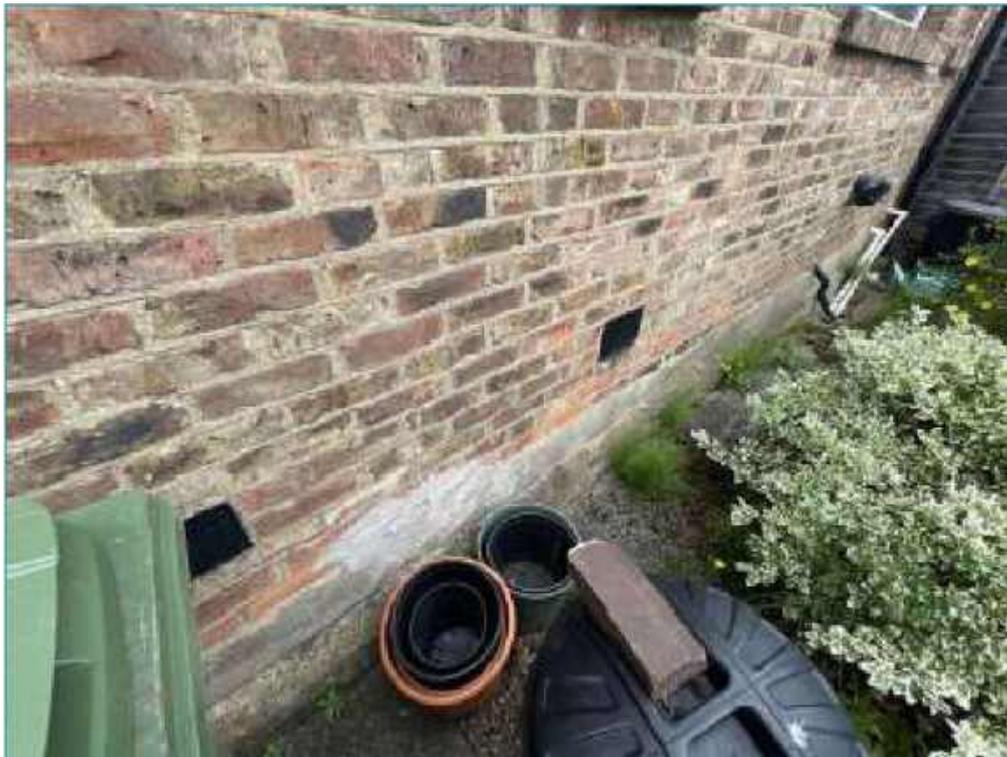
Rear elevation - spalled brickwork and receding mortar

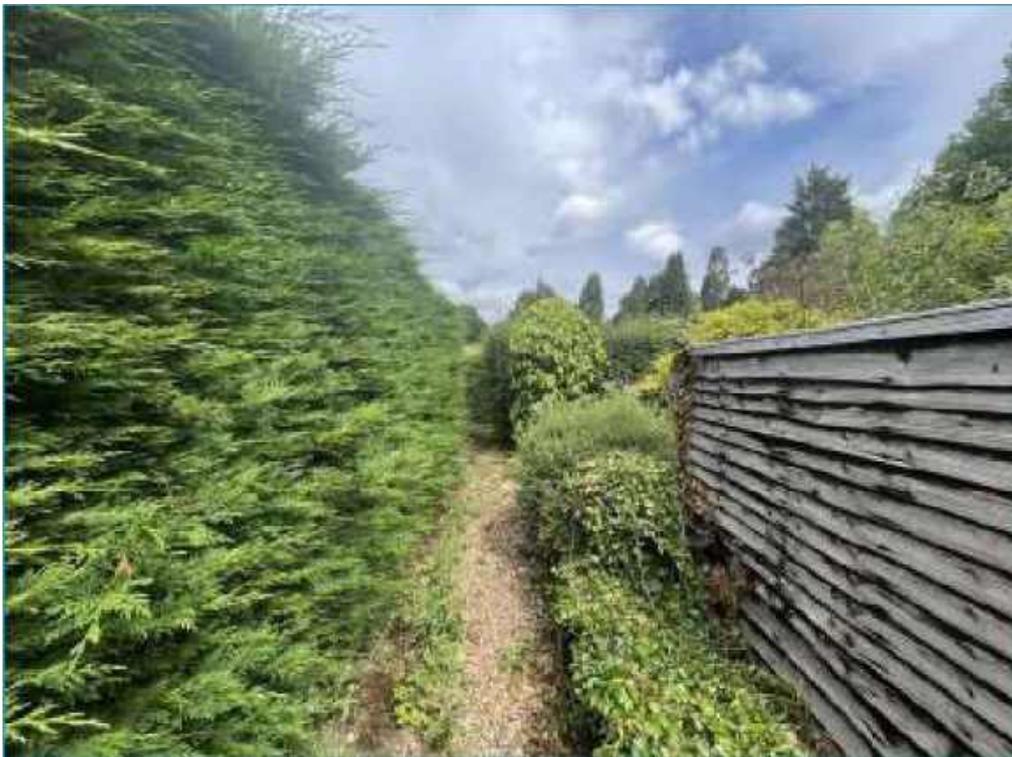
Rear elevation - overgrowth and patio area

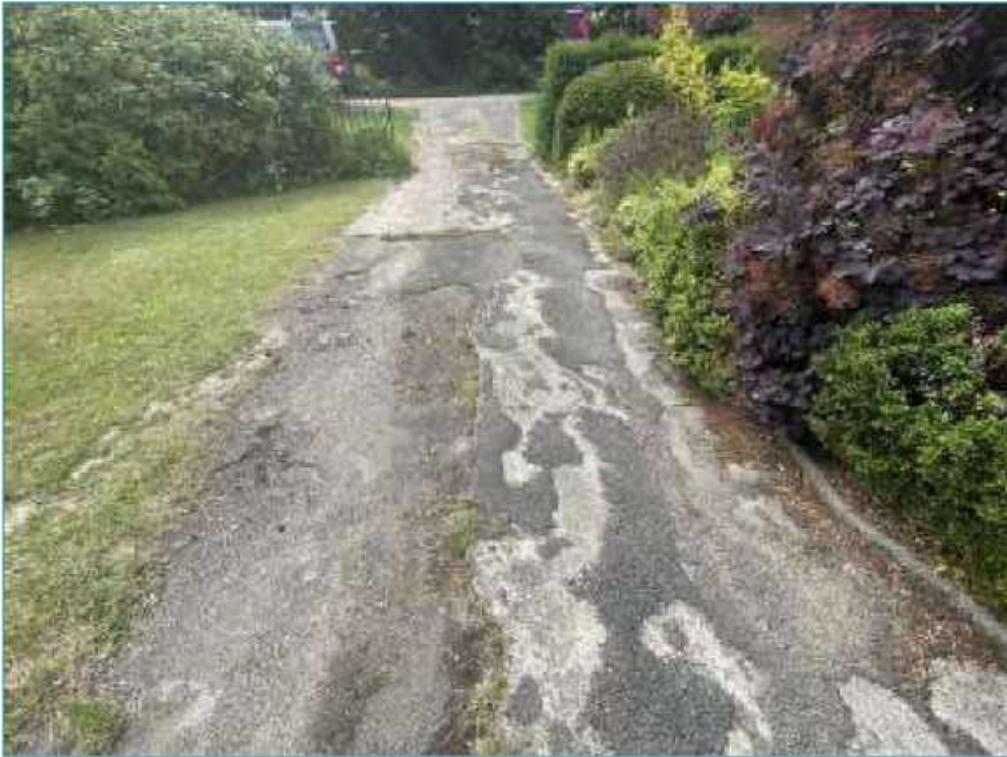
- Repairs to the driveway is required to prevent causing damage to cars coming in and out of the property.

Front elevation - driveway

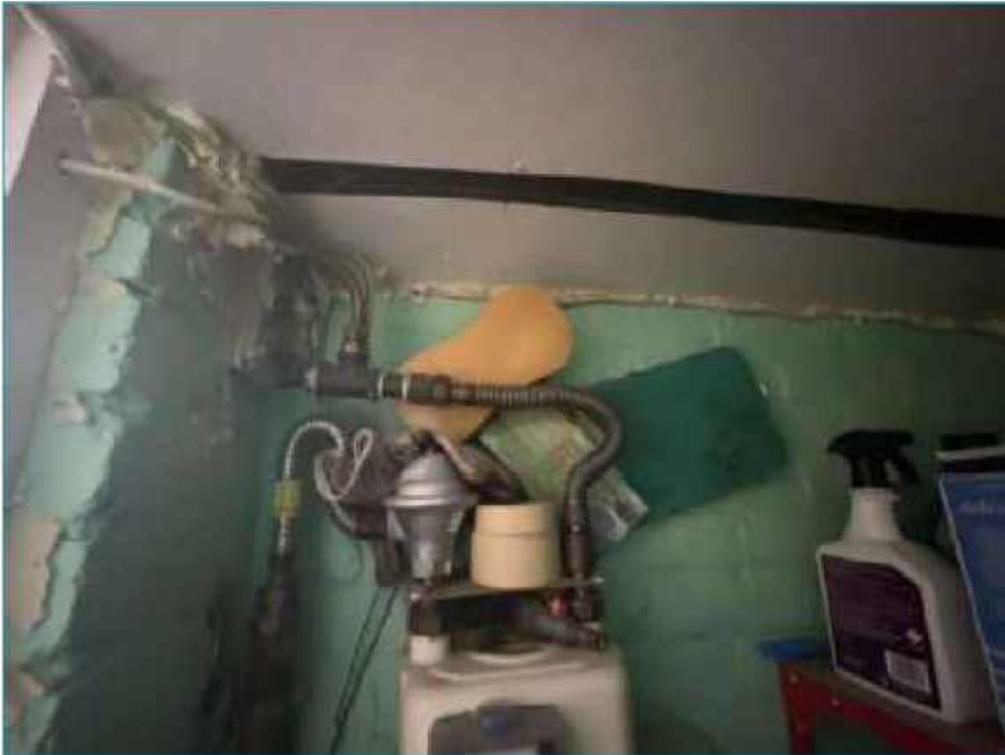
Ground floor - expanding foam around meter

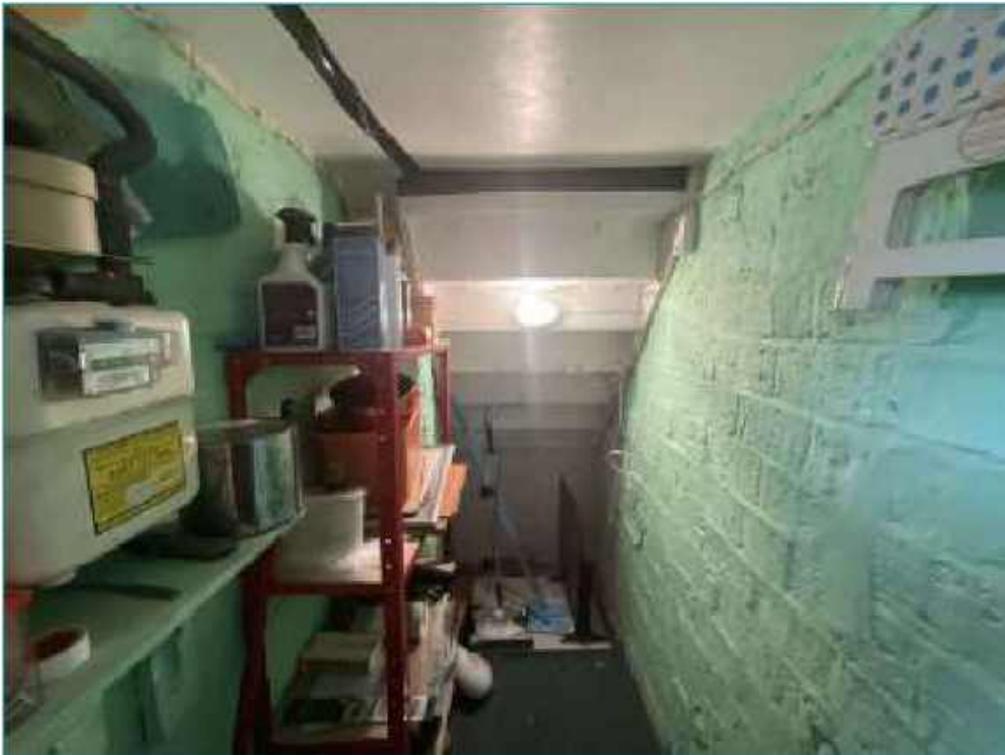
Under-stair area

- The understairs area is to be boarded (exposed timbers) with a fire-rated material to comply with current building regulations and fire safety.
- Some textured ceilings were observed that could be asbestos. This will need to be tested before major works are carried out. This can make sure that any harmful materials are removed by a certified contractor. It was in a reasonable condition with no signs of damaged noted on the day of the survey.
